POOL COMMITTEE REPORT TO THE BOARD OF DIRECTORS

This report describes the work of the Pool Committee, which was formed by the Sunlight Waters Country Club Board of Directors to research options for refurbishing or replacing the existing pool.

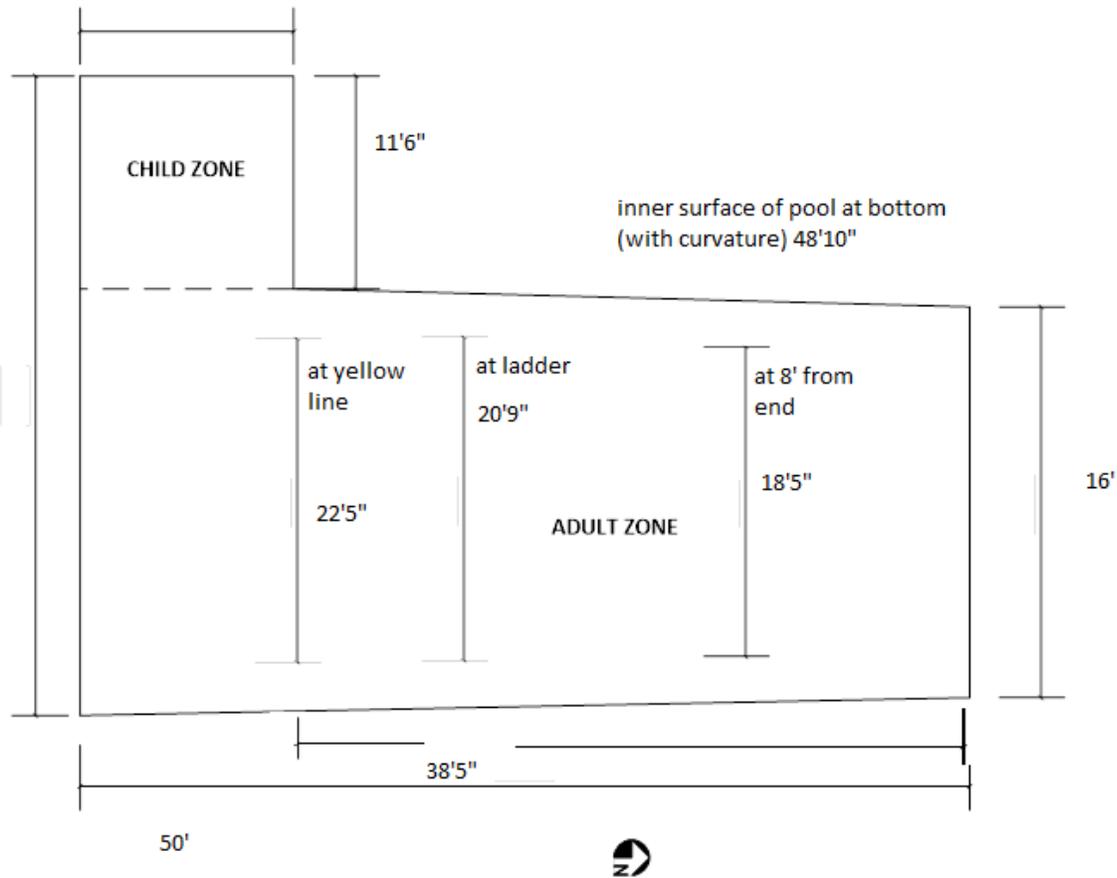
The existing pool is irregularly L-shaped as shown below. The area of the pool in the small child zone is about 144 square feet. The area of the pool in the adult zone is about 1,100 square feet.

Detailed measurements were taken 3/14/2022, to determine whether a fiberglass pool could be fitted inside the existing shell. Measurements were taken at the coping edge.

- End of adult zone: 16 feet
- ~8 feet from end of adult zone: 18 feet 5 inches
- At ladder: 20 feet 9 inches
- At yellow marked line: 22 feet 5 inches
- From east side to end of L: 38 feet 5 inches
- Width of L-shaped portion: 11 feet 6 inches
- N-S length of adult zone: 50 feet
- Inner surface of pool at bottom (curvature): 48 feet 10 inches

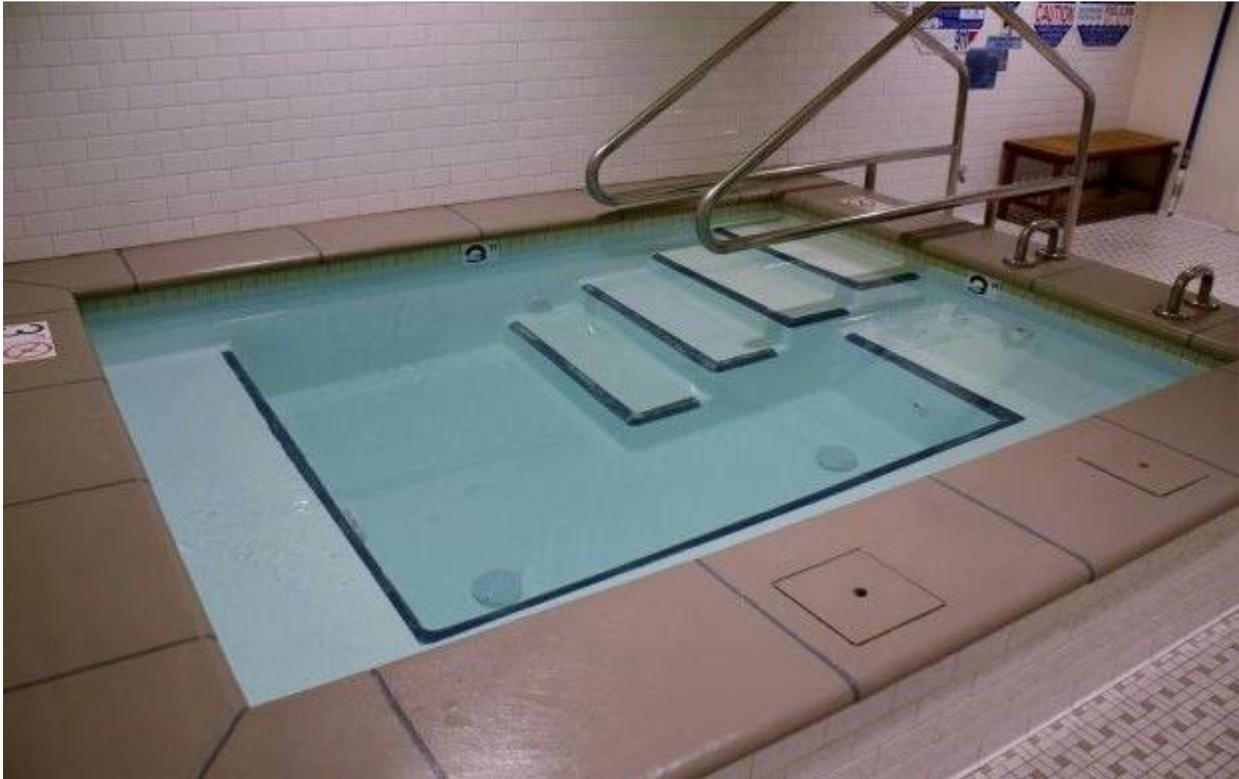
Example of a larger rectangular spa:

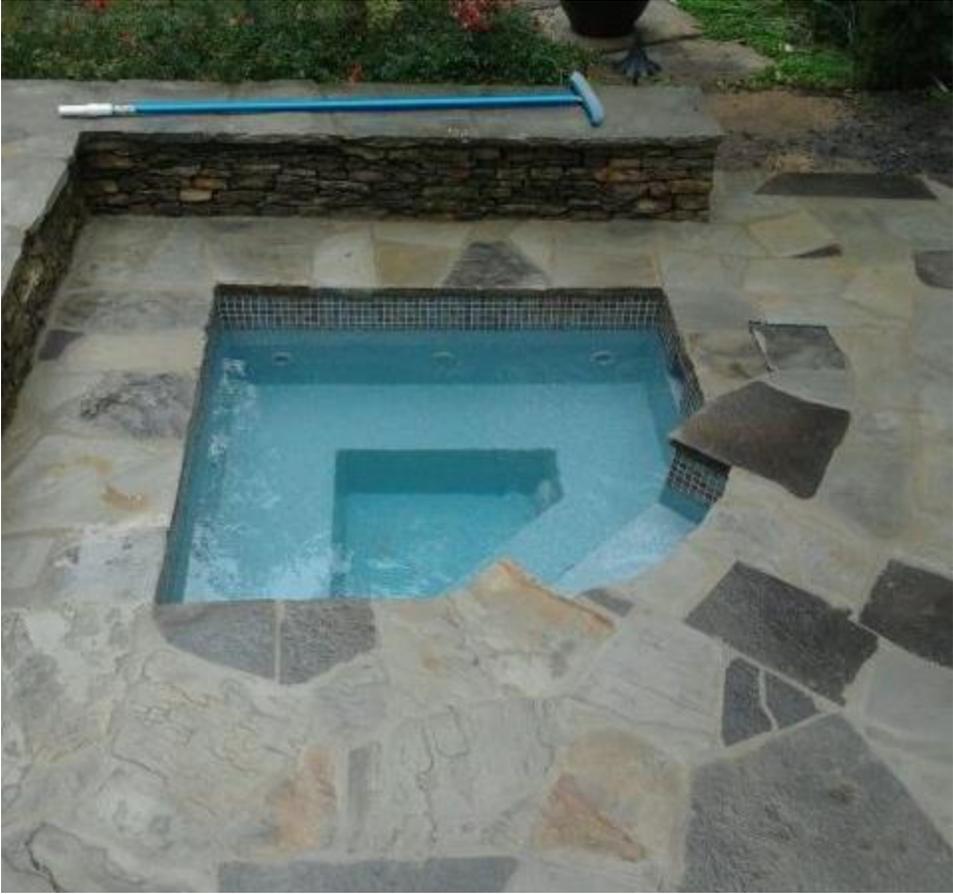
Example of a smaller square spa:
